Article Title: Digging at Fort Kearny

Article Summary: The Nebraska State Historical Society provided an analysis of historical resources to guide archeological excavations at Fort Kearny in 1960 and 1961. Archeologists were able to compare their findings with period maps and plans from the Society's collections.

DIGGING AT FORT KEARNY

BY ROGER T. GRANGE, JR.

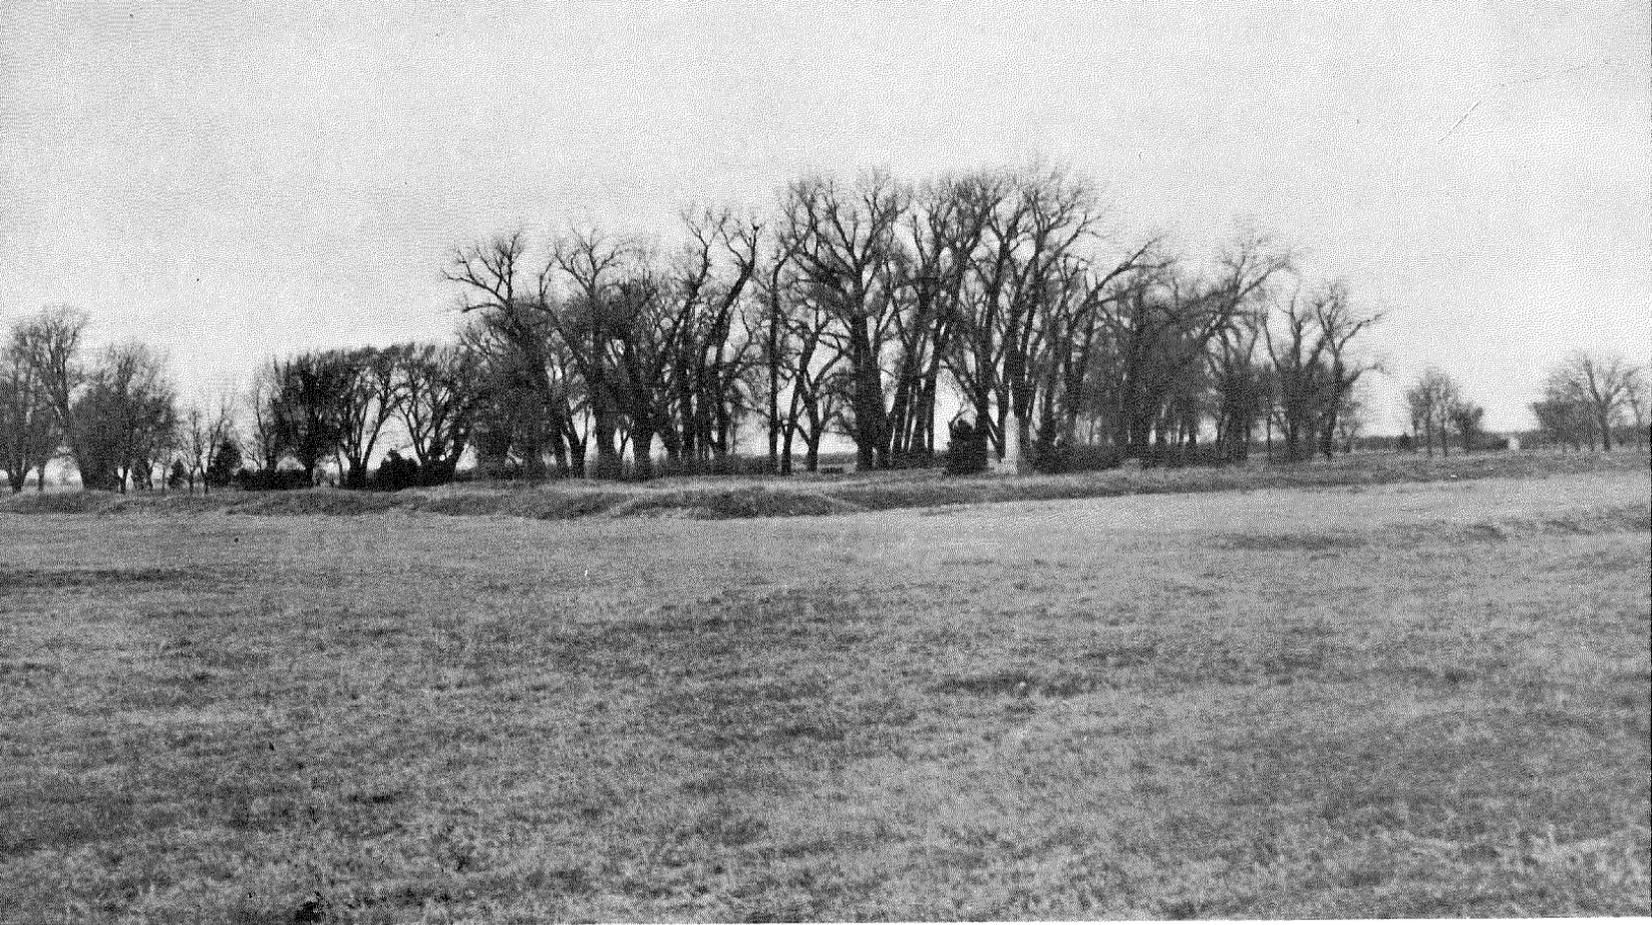
Fort Kearny in the 1950's

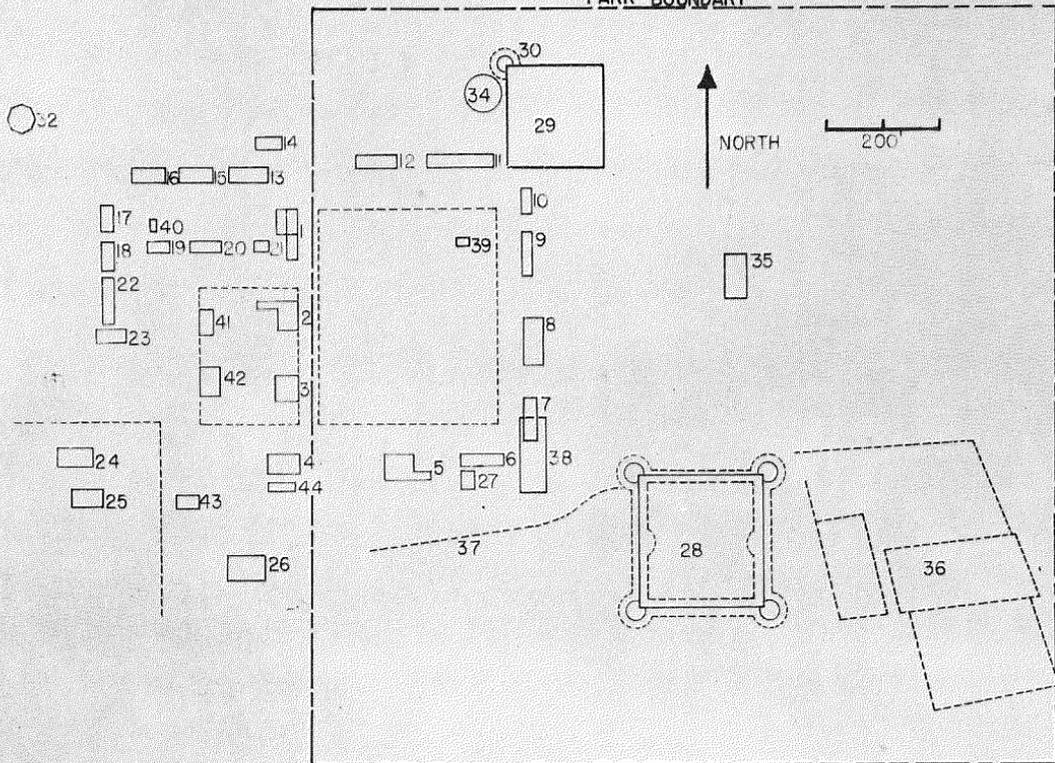
Composite Plan of Fort Kearny in 1864

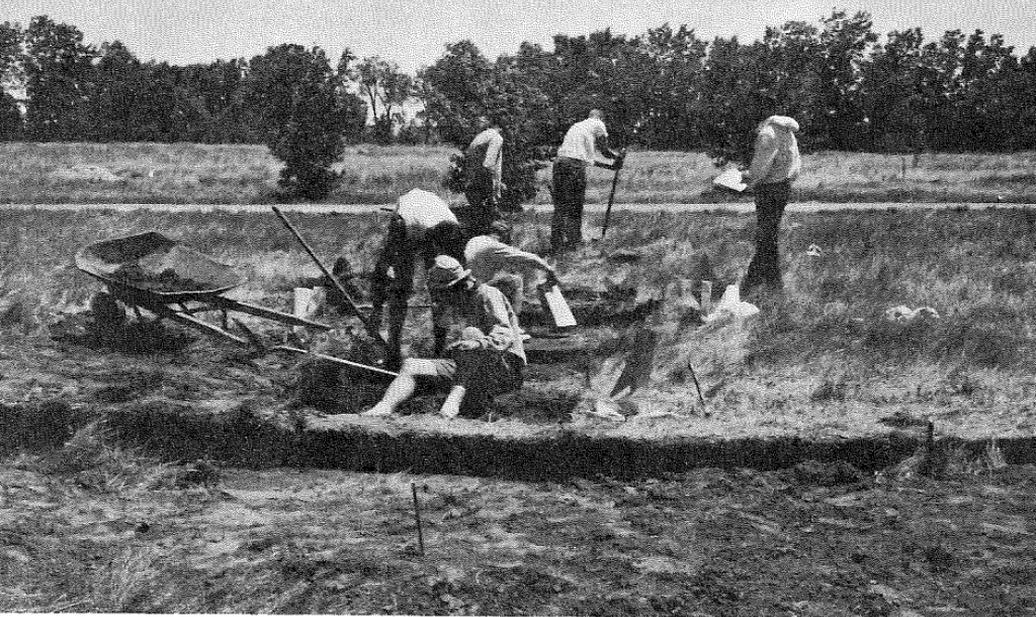
Above—Crew excavating blacksmith-carpenter shop.
Below—Remains of blacksmith shop forge.

The earth comprising the mound was composed of dark grey to black soil and refuse consisting of charcoal, ash, brick rubble and artifacts. Detailed study of the north-south longitudinal trench revealed that the building had been divided into two rooms by an interior sod wall. A layer of ash was found on the earthen floor of the northern room, along with scrap iron, broken blacksmith tools, window and bottle glass fragments and food bones. The most prominent feature of the excavated area was a large concentration of ash, clinkers, brick rubble and scrap iron surrounding a small section of standing bricks mortared together. This feature has been tentatively identified as the remains of a forge. The layer of floor ash runs continuously underneath the mortared bricks, demonstrating that this particular forge was a later addition to the building. Outside the northern room of the building to the west was a depression which may mark a worn spot or mudhole at an entrance of the building. Associated with this depression was found a mass of worn-out horse and mule shoes, wagon parts and other scrap iron which appears to be a waste iron pile. The southern room of the building lacks the well defined layer of ash on the floor although two ash filled pits were found in the floor level. Fragments of saws and files as well as scrap iron were found in this section of the building which has been tentatively identified as the carpenter shop area.

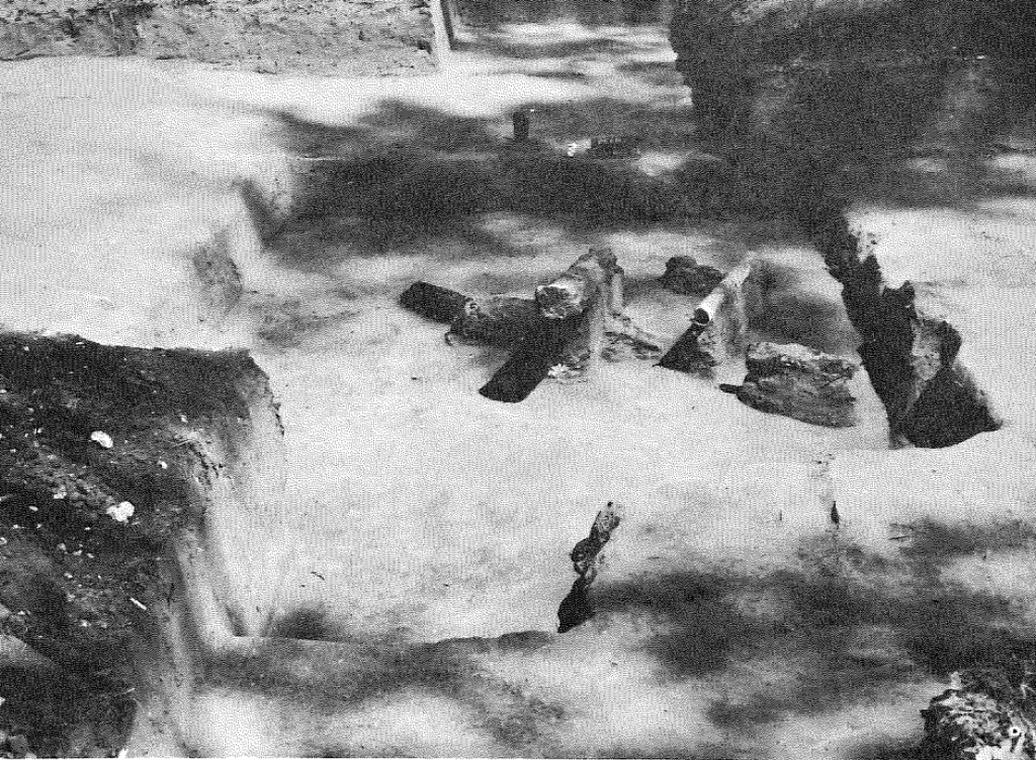
Above—Floor depression of guardhouse after excavation.

The building was found to be defined by a rectangular excavated floor pit and a short projecting entrance passage which connected with a gravel walkway running between the rows of stately cottonwoods lining the northern side of the parade ground. Little evidence remained of wall or support posts. Charred cedar log fragments, probably roof timbers, in the center of the floor depression suggest that the building may have burned although there was not a great quantity of charcoal or ash in the mound fill.

Evidence based on location of this feature suggests that it is the 1852 guardhouse, but it is difficult to reconcile the central sub-floor depression and its 8 by 15 foot dimensions with the historical map data concerning this structure. The lack of positive evidence of walls beyond the limits of the floor pit may indicate that poor preservation prevents an accurate archaeological delineation of the building.

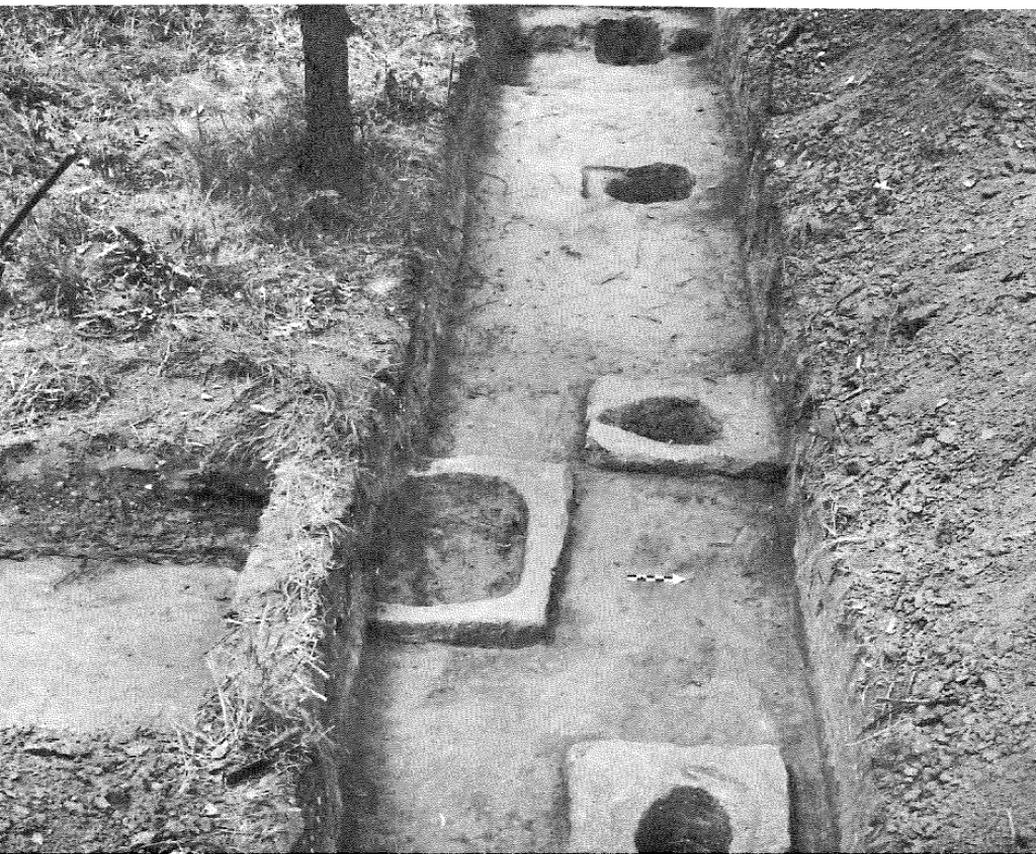
Below—Trench exposing postholes marking barracks foundation.

No trace of either of these structures can be clearly seen on the existing surface although some artifacts were present. The probable locations were determined by analysis of the historical maps and then trenches were excavated to explore the area for evidence which would confirm their identification. Post molds and cedar posts were found in the trenching operation; in one case an underlying horizontal cedar plank had been used to shore up a rotted foundation pillar. Measurements based on the post pattern suggest a building width of 24 feet comparing favorably with the map dimensions of the structures. Length of the buildings was not tested archaeologically.

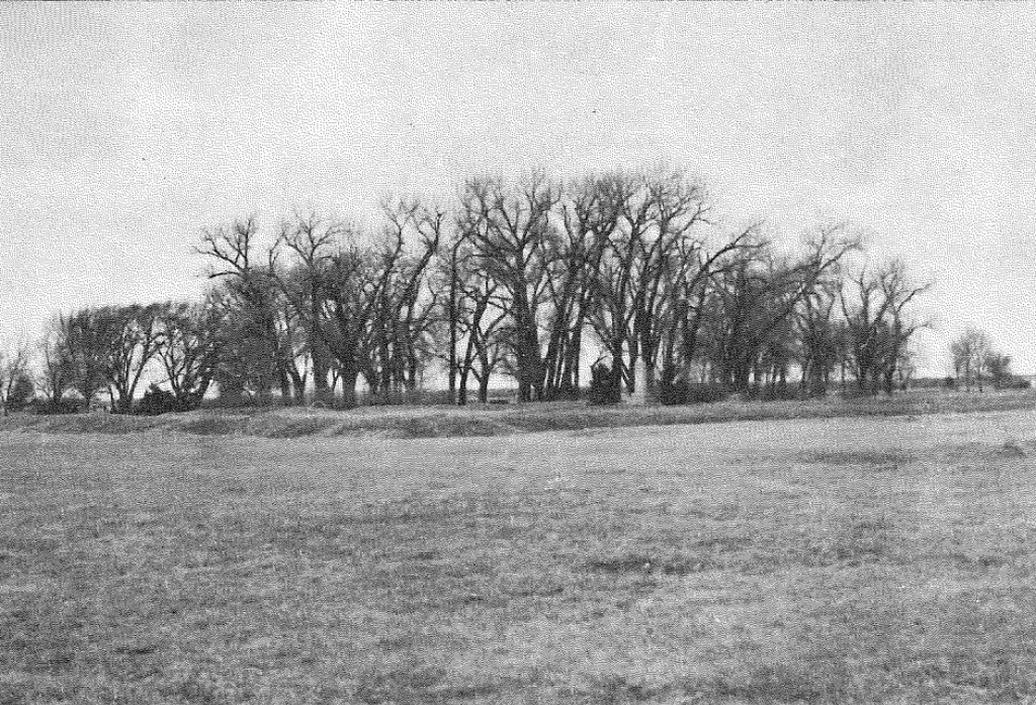
Above—Fort Mitchel earthworks before excavation.

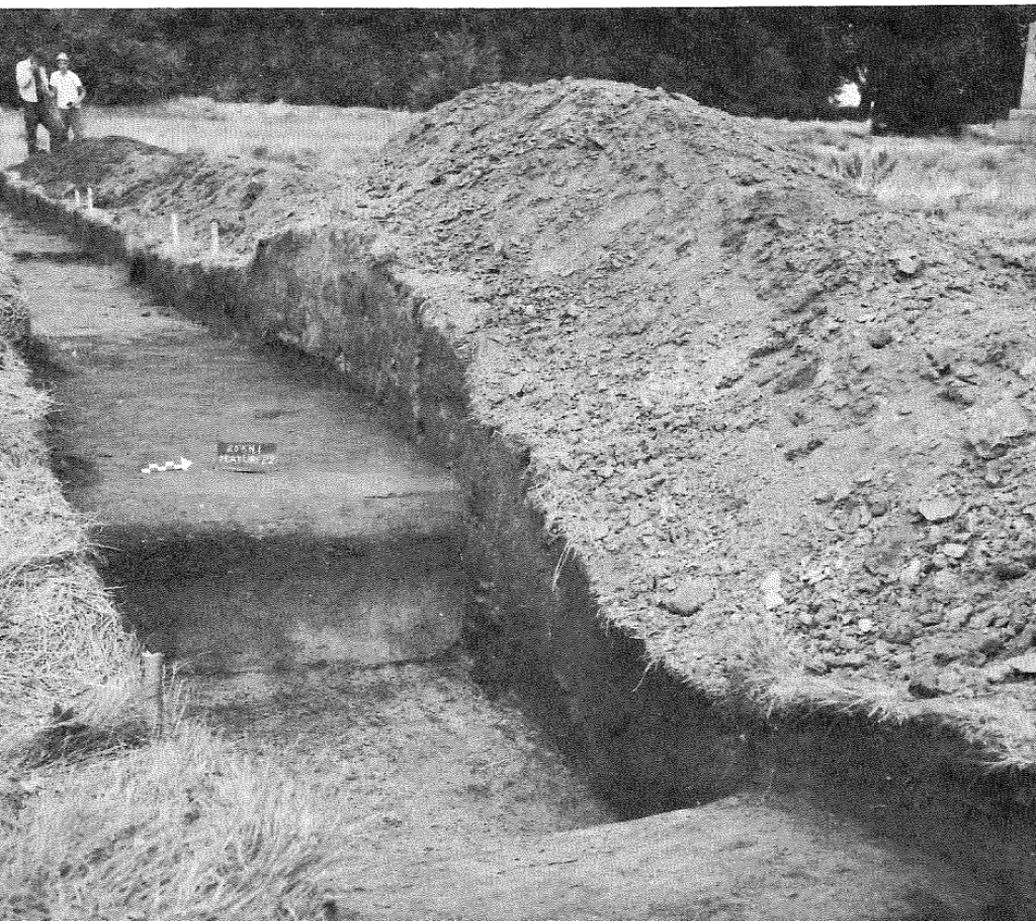
Below—Trench through mound and ditch of Fort Mitchel fortification.

The area enclosed by the earthwork has a layer of dark stained soil including scattered refuse. The fill of the earthwork mound is mottled in nature, ranging in color from yellow to black, and consists of soil removed from the associated ditch. Scattered artifacts were found in the mound; these were either from the former surface trash or refuse deposited in the mound fill.

The scarp or inner face of the ditch was lined with sod blocks which could be seen cross-sectioned in the trench profiles and in horizontal outline along the ditch. The ditch fill is uniformly dark and similar in color and texture to sod blocks observed elsewhere in the excavations. The mound fill is primarily light colored and mottled. These

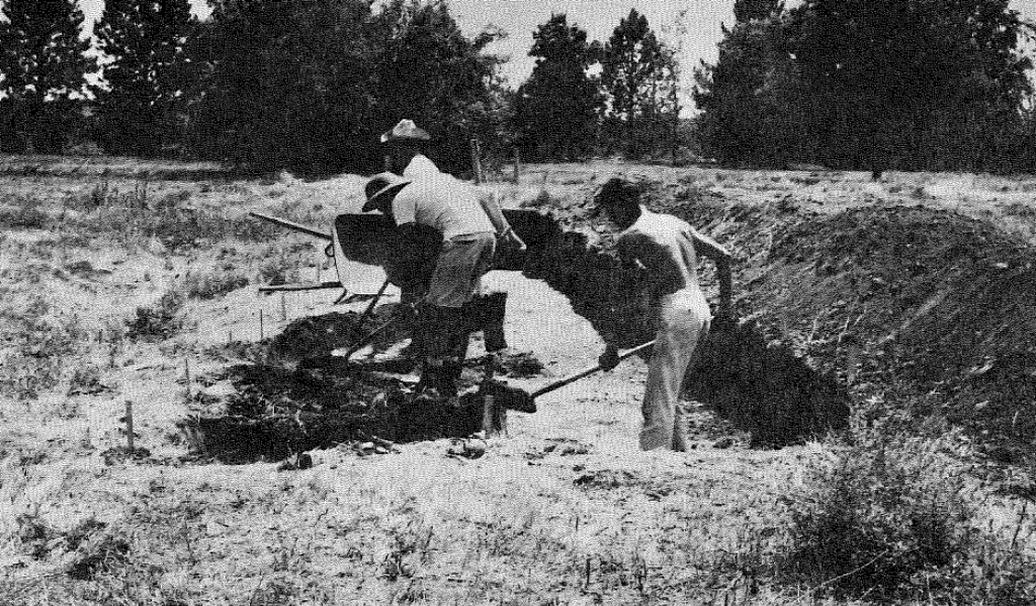
Above—Excavating east side of Fort Mitchel.

During the two seasons' work the eastern side of Fort Mitchel was extensively excavated and a series of cross-trenches were excavated to determine the nature of a sod building found in association with the earthwork. The southeastern bastion and part of the northeastern bastion were also excavated.

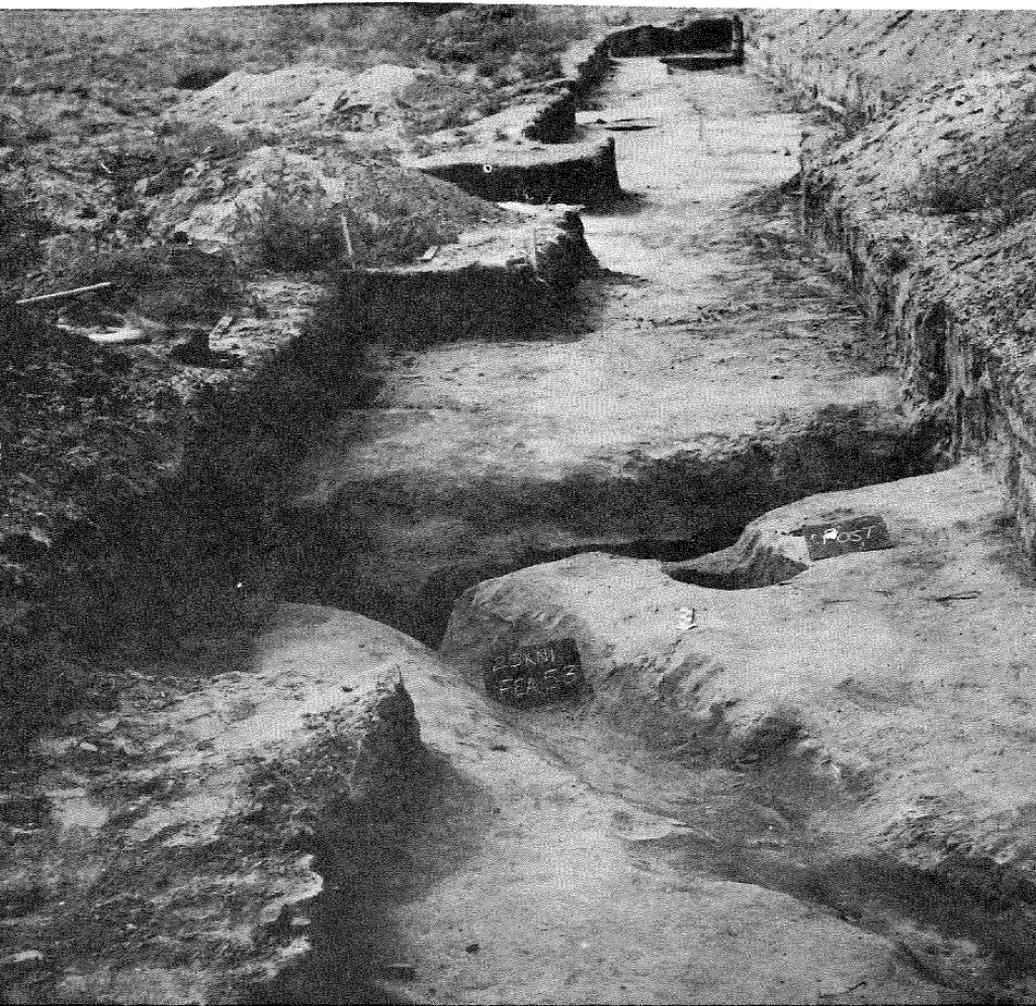
Below—East side, Fort Mitchel; angular trench is part of earlier building.

The lack of evidence concerning the superstructure may in part be due to the unexpected complexity of the east side of the earthwork because the foundations, posts and rubble of an earlier sod building were found underlying the parapet and cut by the ditch. Furthermore, the upper portion of the mound has eroded considerably and it is likely that most evidence of the rotted butts of the stockade facing planks has been destroyed by natural forces.

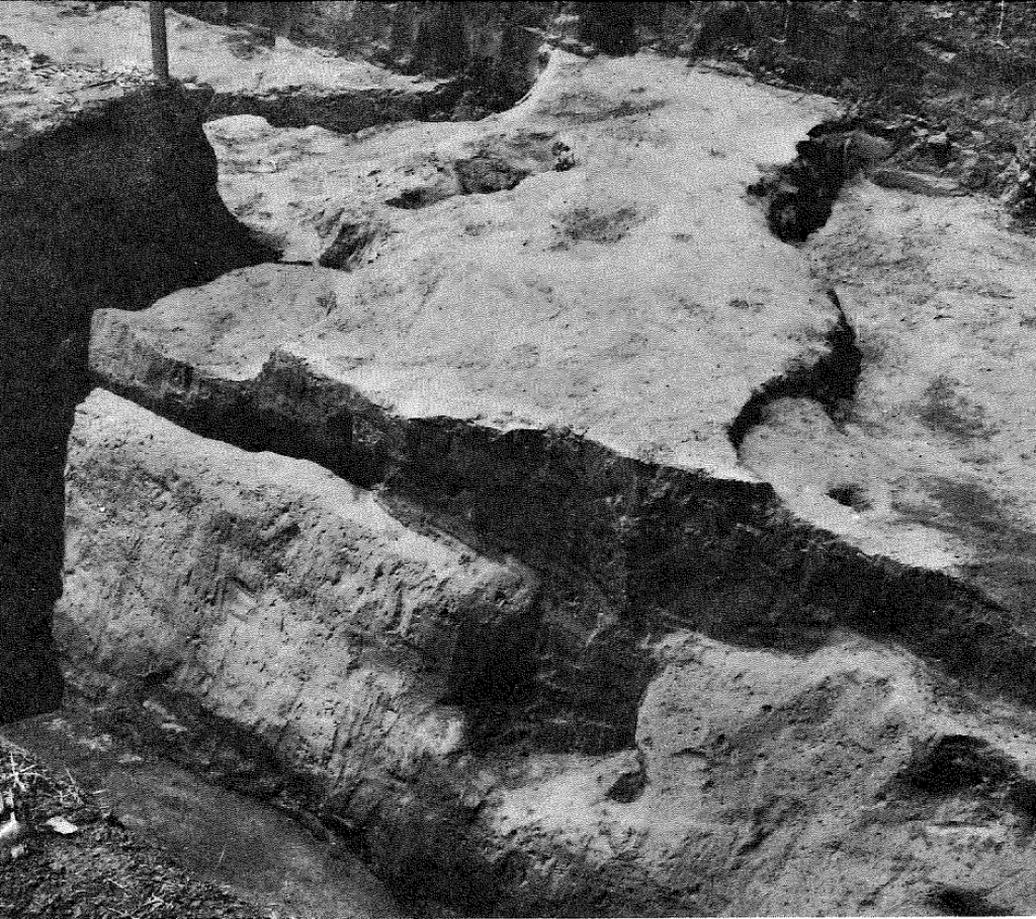
Above—Wall of sod structure cut by fortification ditch.
Below—Collapsed sod wall of building in Fort Mitchel site.

In the center of the mound a layer of two courses of sod blocks was clearly seen in the north-south profile of the southern third of the earthwork. In the central portion of the fortification mound the mottled fill tapered and was replaced by a layer of dark soil and brownish organic material. This section of the parapet was formed by the eroded earth and rubble of a collapsed sod building which was in ruins when the fortification was constructed in 1864.
